Service/product: Critical Asset Inspection

Customer: Scottish Water

The challenge

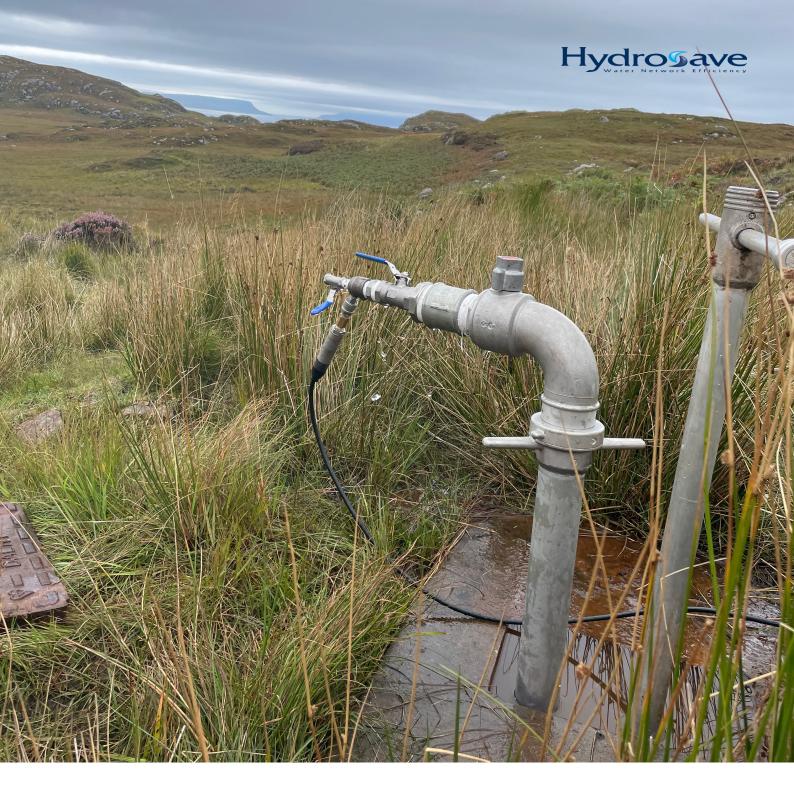
Hydrosave utilised their innovative and patented pipeline deterioration technology designed by Adelaide University and owned by partner company Detection Services Pty of Australia. pCAT™ Infinity uses inverse transient analysis to measure and determine the condition of pipelines by not only providing pipe wall and lining loss data but also anomalies such as changes in material and size, air/gas pockets, blockages, connections and valve status. The 1.8km of interest was split into two sections with the wave profiles being generated and received using existing hydrants and an air valve. The wave size was between 5 to 7mhd and generated by the release of up to 10 litres of water which had the hydrant flow isolated instantly with the two data systems connected using GPS technology.
