Scottish Water Aganova Case Study

Pipeline inspections for Scottish Water using Aganova's Nautilus technology

In March 2025, Scottish Water needed to inspect a 29.2km cast iron raw water pipeline between Baddinsgill and Pateshill near Edinburgh.

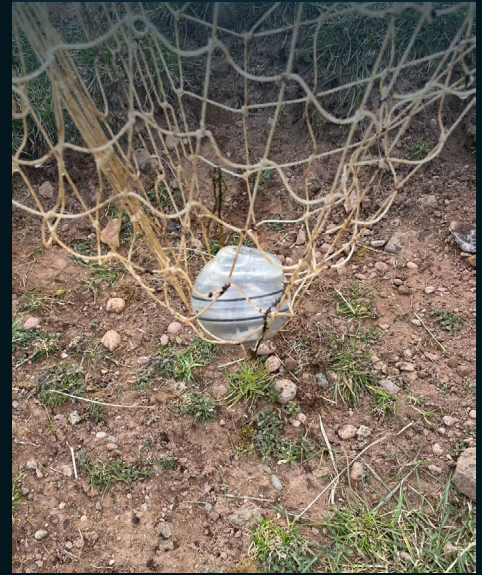
- The state-of-the-art 70mm Nautilus sphere moves with the water flow and collects acoustic and pressure data
- The sphere uses cutting edge sensors and AI-driven analysis to detect leaks, air pockets and structural anomalies with high accuracy.
- Timed acoustic devices, known as synchronisers, were placed along the pipeline to help pinpoint incidents to the nearest centimetre.

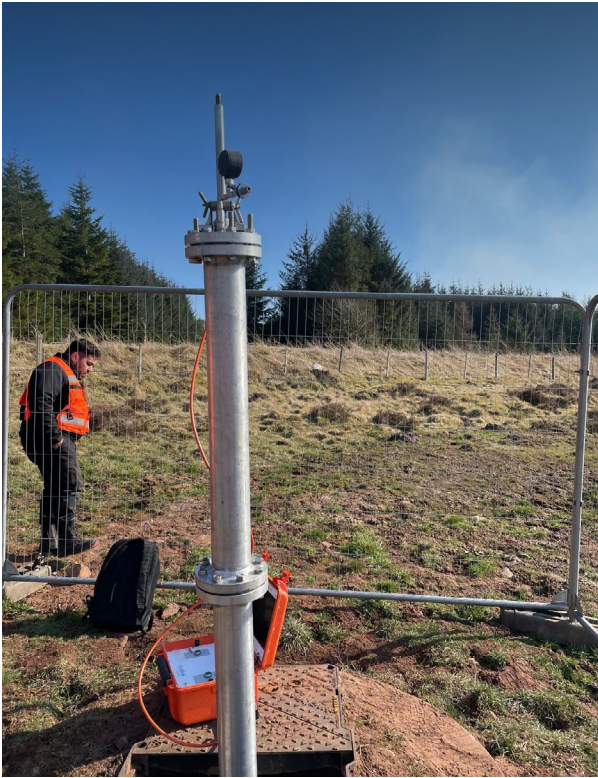
We performed the inspection at a working flow rate of approximately 183 litres per second. Insertion and retrieval of Nautilus was carried out through DN150 gate valves, enabling full access without service disruption.
